TWA Flight 800

The Devil is in the Details

by Robert W Allardyce & Captain Howard Mann (TWA, retired)

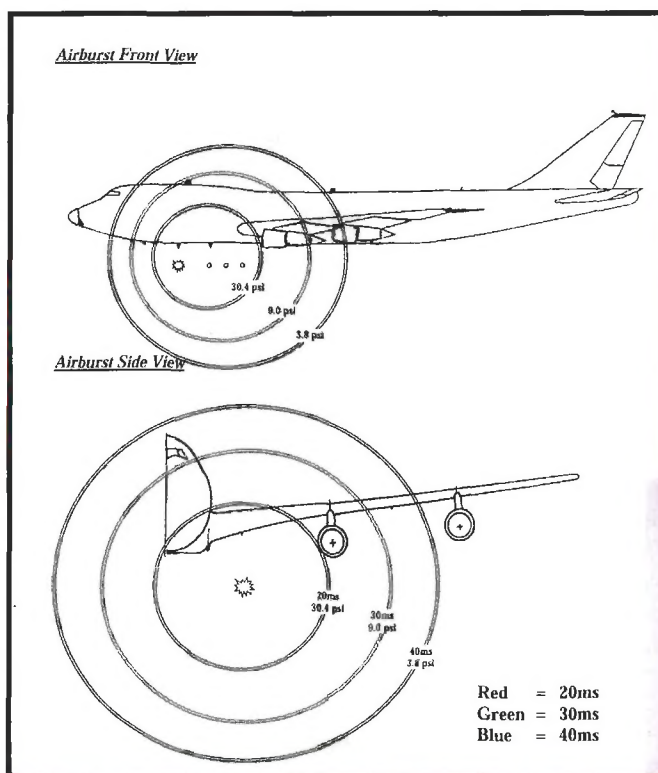
TWA 800 fuselage reconstruction. A photograph taken by the NTSB of the left side of the fuselage. The site of the breach was roughly abeam the L2 door.
